**FIELD ACTIVITIES REPORT
Mine Adit Entry**

**RED AND BONITA MINE SITE
Silverton, San Juan County, Colorado**

TDD No. 1008-01

January 20, 2012

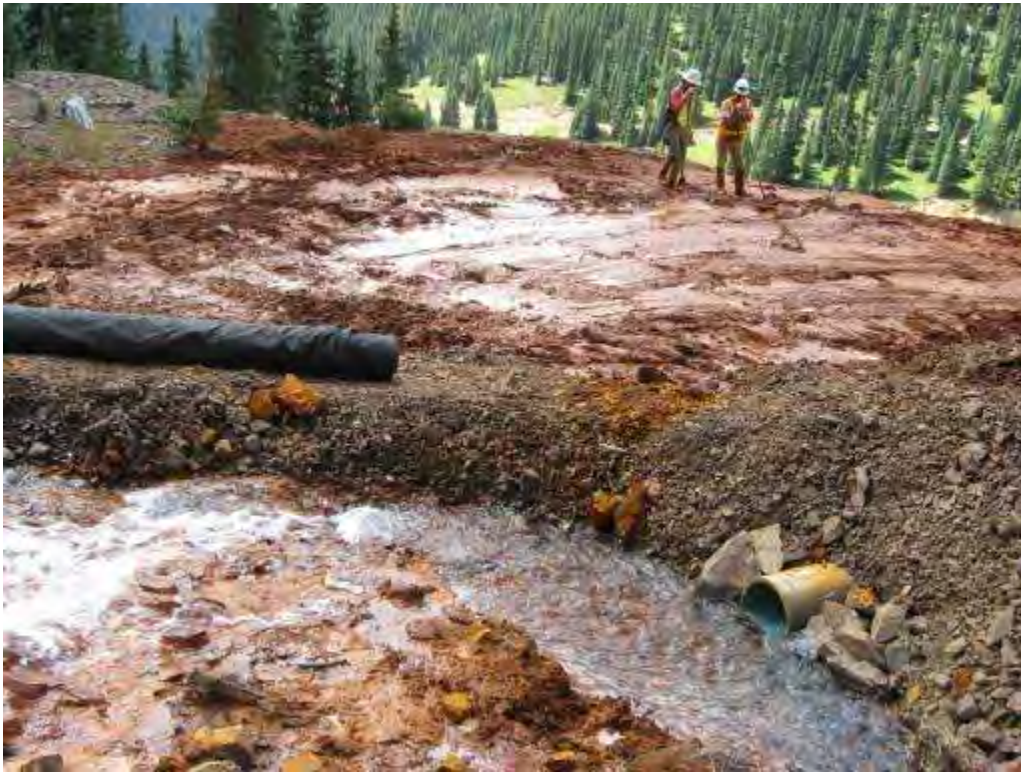
PHOTO 15 8-30-2011

Decanting water from yellow boy solids on dump surface. Temporary underflow pipe diverting adit water to north side of dump.

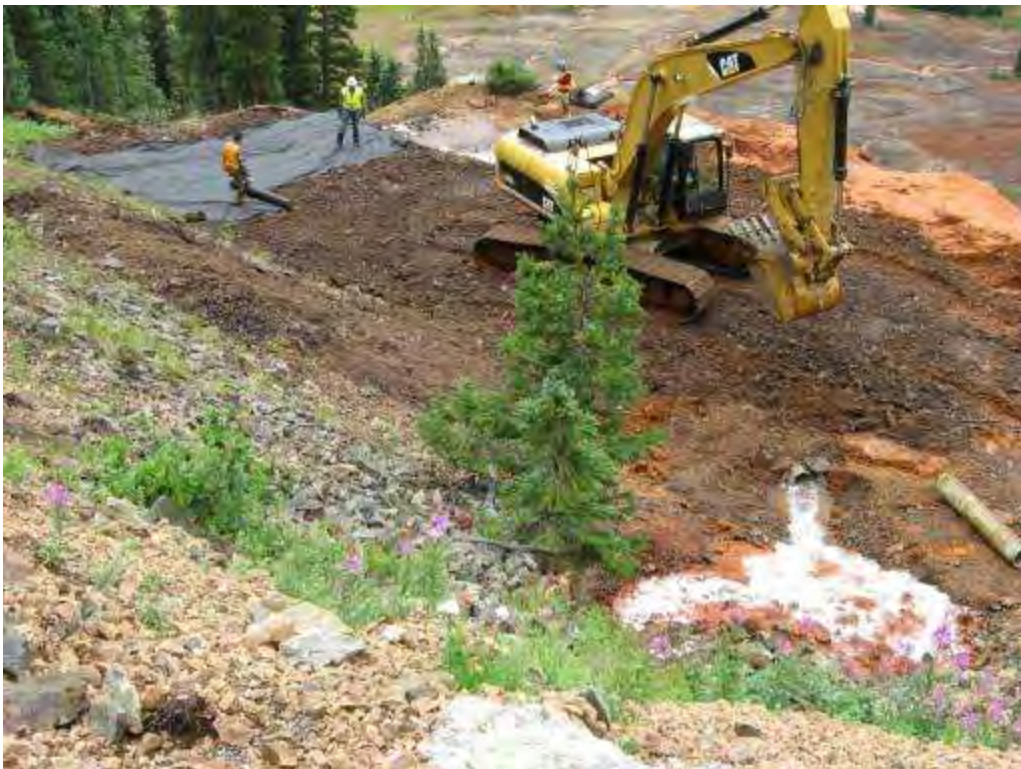
PHOTO 16 8-31-2011

Talus material placed over geotextile fabric that was placed over base talus material on dump surface. AMD discharge from collapsed portal in lower right, under-piped to south ditch. See also Photo 17.

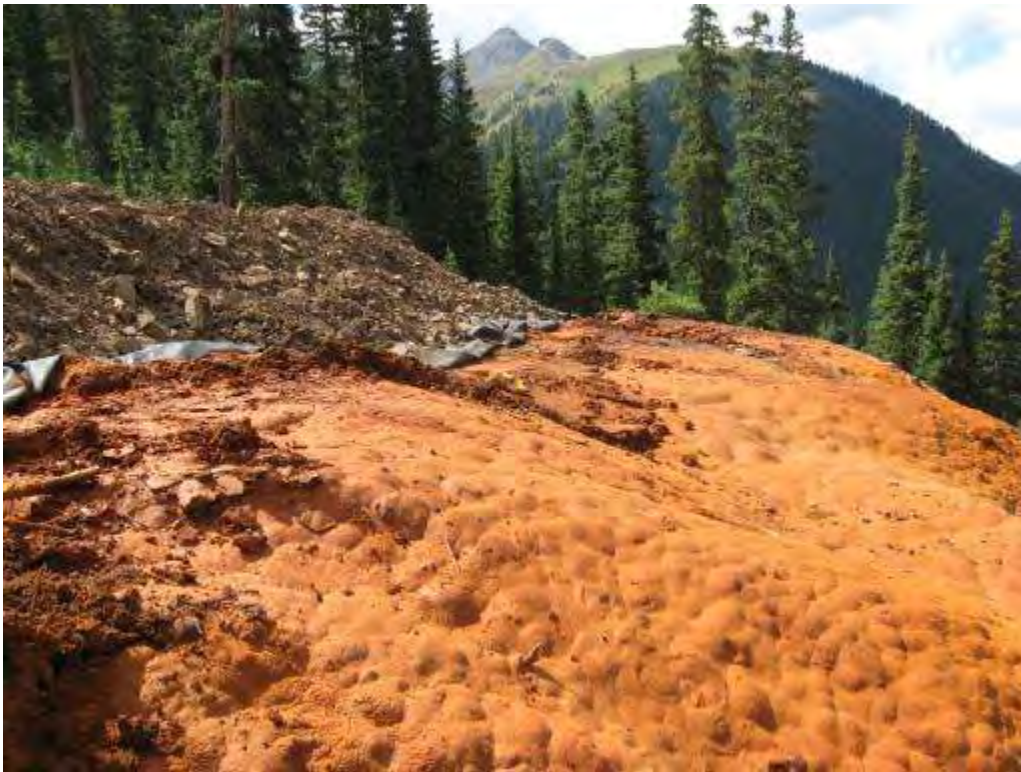
PHOTO 20 9-8-2011

Toe of prepared dump surface at head of dump face. Note geotextile fabric liner exposed under talus, and armored yellow boy surface on dump face.

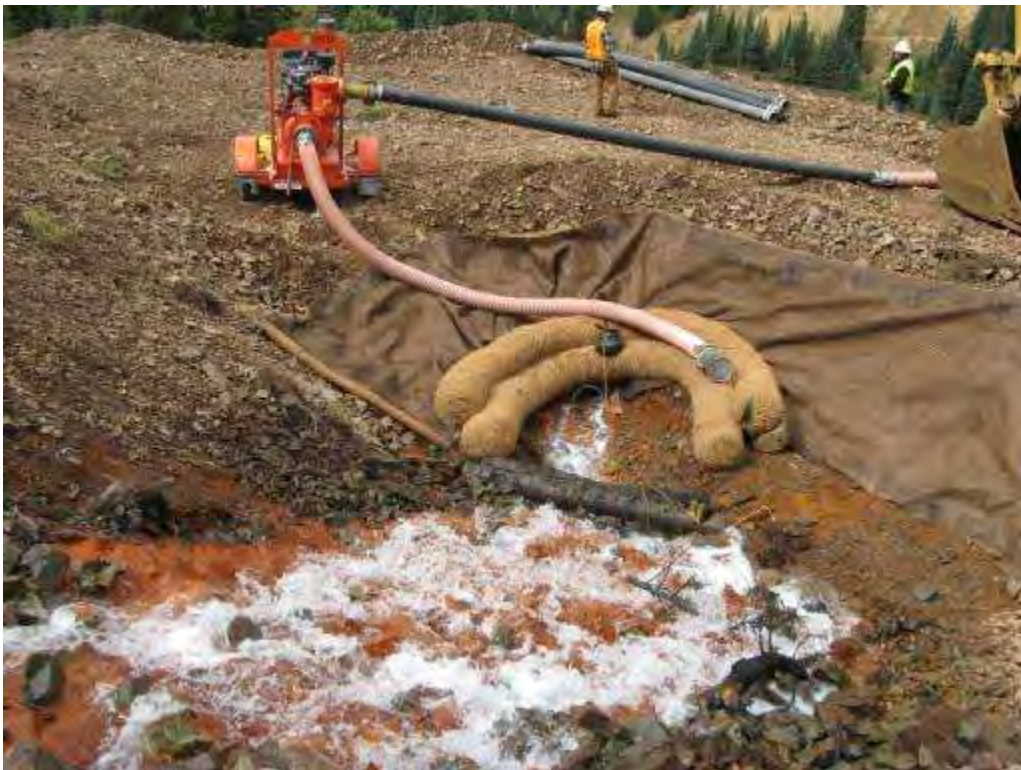
AMD effluent water from the collapsed mine portal was captured into an approximately 10-foot diameter sump (Photo 22) constructed from talus material near the mine portal where it could be diverted to one of two locations, dependent upon need:

PHOTO 22 9-10-2011
Koir-Logs®, filter barrier, and pump at sump below the adit outflow. Twelve-inch PVC pipe under Koir-Logs® directs water to south ditch when not being pumped to manifolded filter bag apparatus at toe of dump. Pipe can be plugged with stopper, stored on Koir-Log® in photo center.

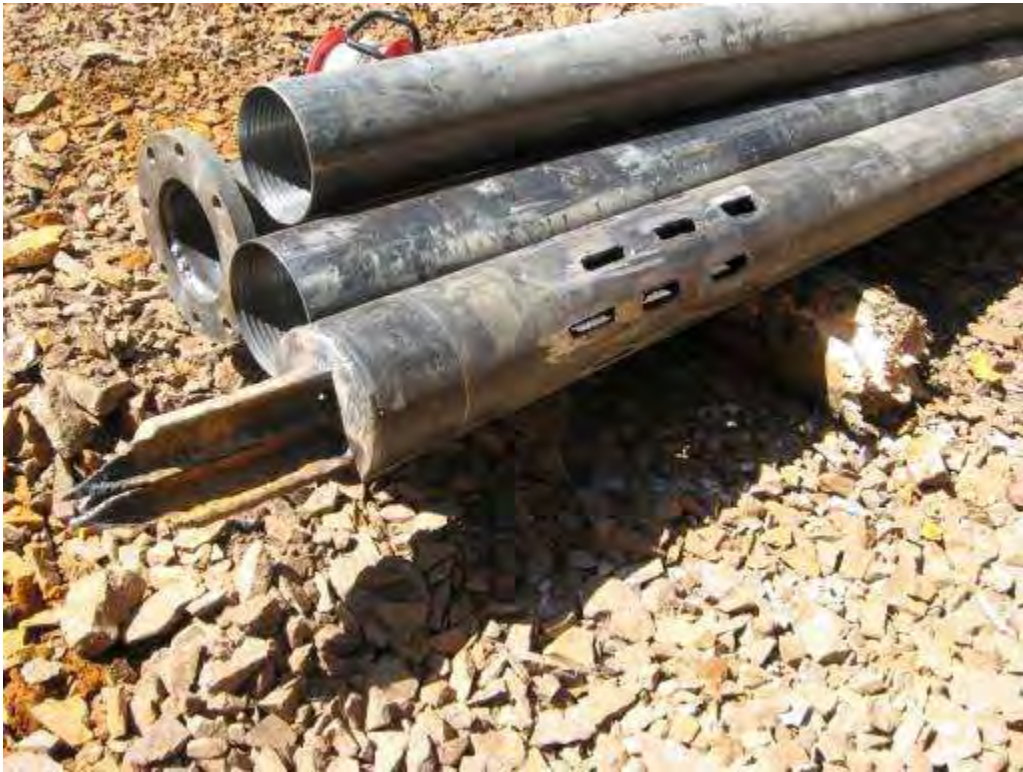
PHOTO 33 9-22-2011

Once the mine adit outline within competent rock was established by removal of much of the collapsed material, a 40-foot long, 6-inch diameter steel pipe was inserted into the mine adit through the remaining portal collapse (Photo 33). The pipe was used to pump water from the adit in order to reduce head pressure on the remaining portal collapse so additional excavation could be performed safely. The pumping rate through the pipe was monitored to gain insight regarding the potential of additional blockages inby of the mine portal by observing water extraction and recharge rates.

Schedule 40, 6.63-inch OD, flush-threaded steel pipe. Assembled during placement into mine adit. Used to pump AMD water from adit in controlled conditions.

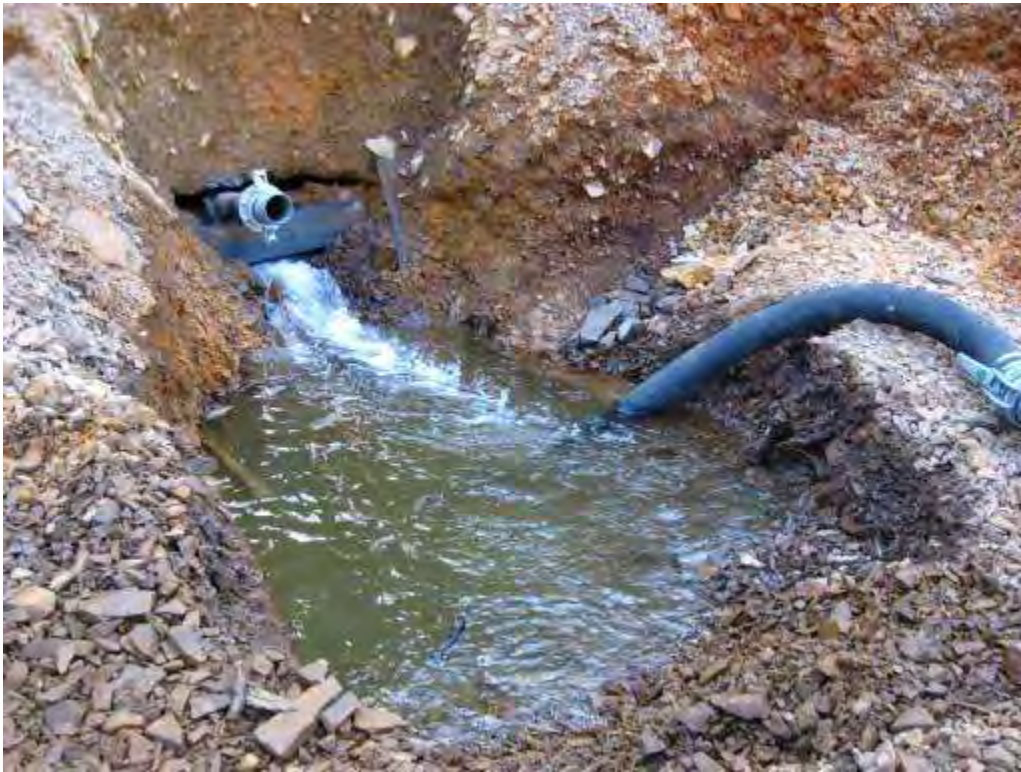
PHOTO 35 9-27-2011

Pumping water through hose from sump at excavated portal. Steel pipe placed in adit is visible resting on header above current collapse blockage.

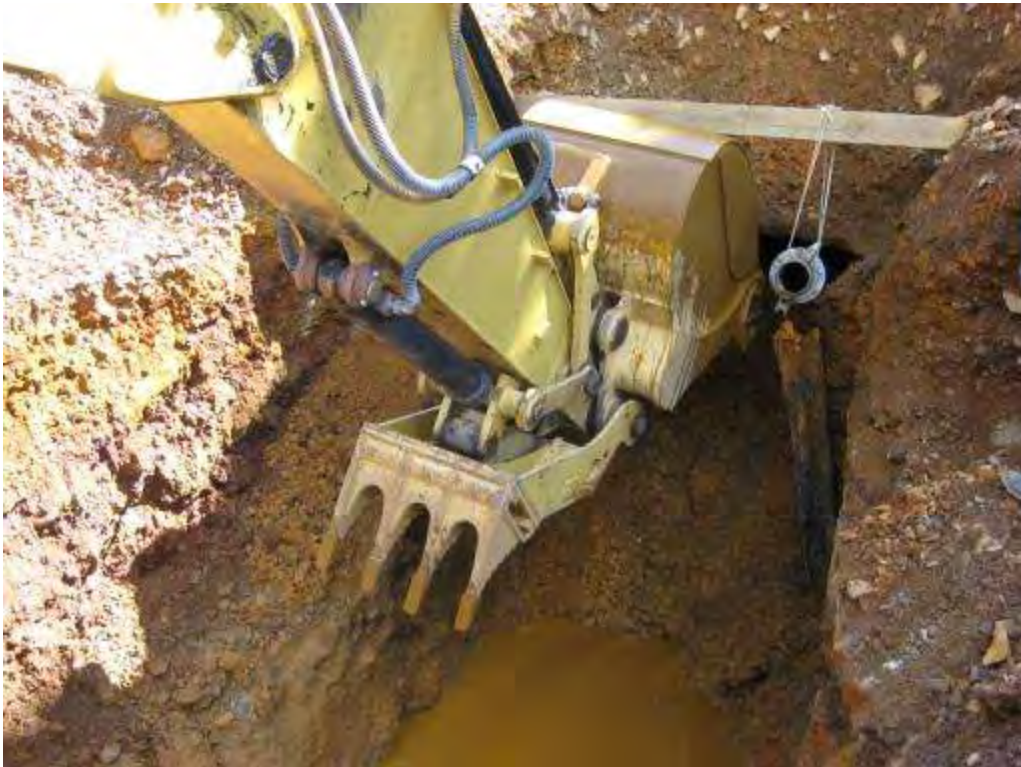
PHOTO 38 9-29-2011

Removing upper portion of remaining collapse material to allow AMD water to flow out of adit.

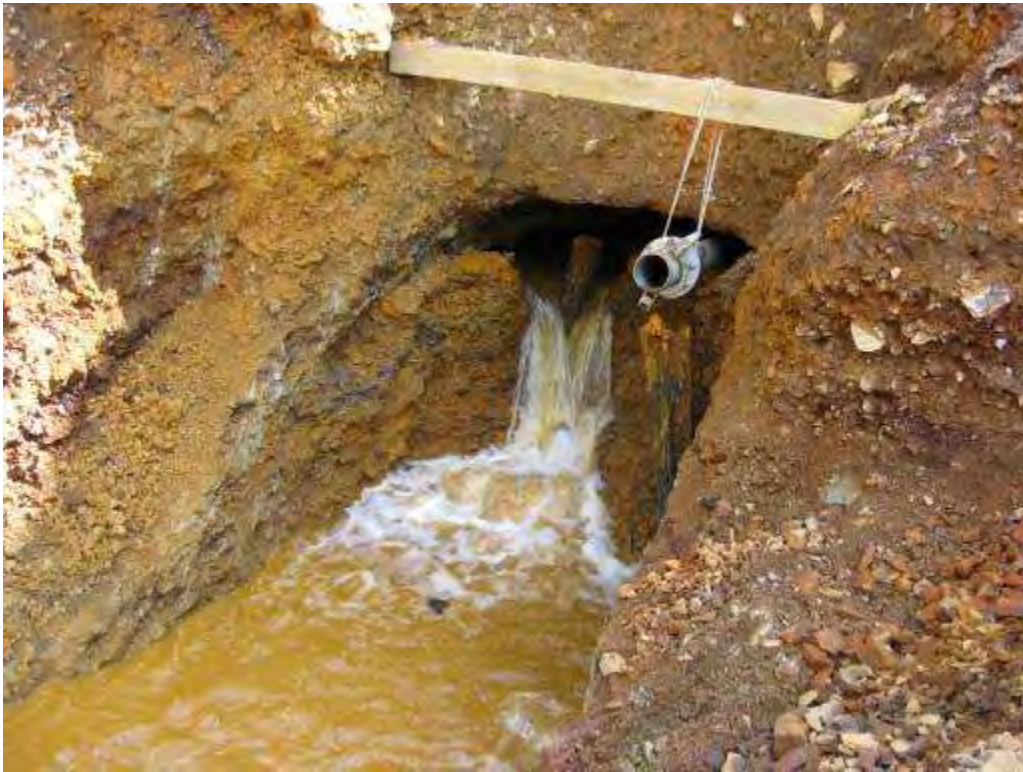
PHOTO 39 9-29-2011
AMD water flowing from adit.

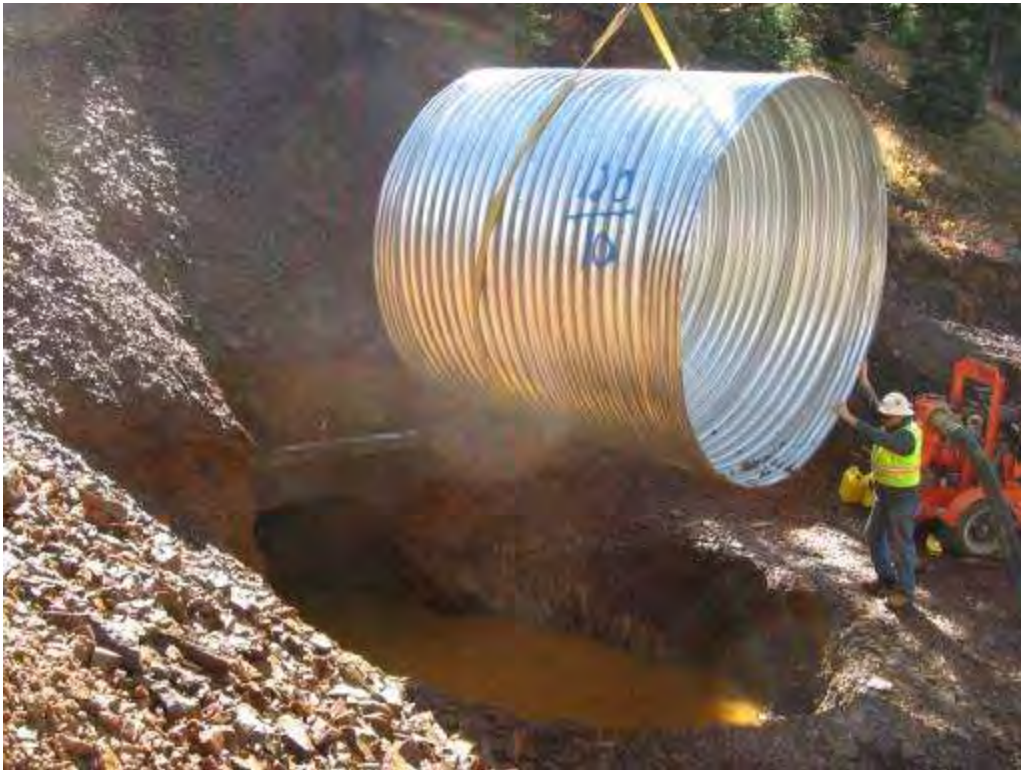
PHOTO 42 9-30-2011

Placing portion of new portal structure. Ten-foot diameter galvanized steel culvert pipe.

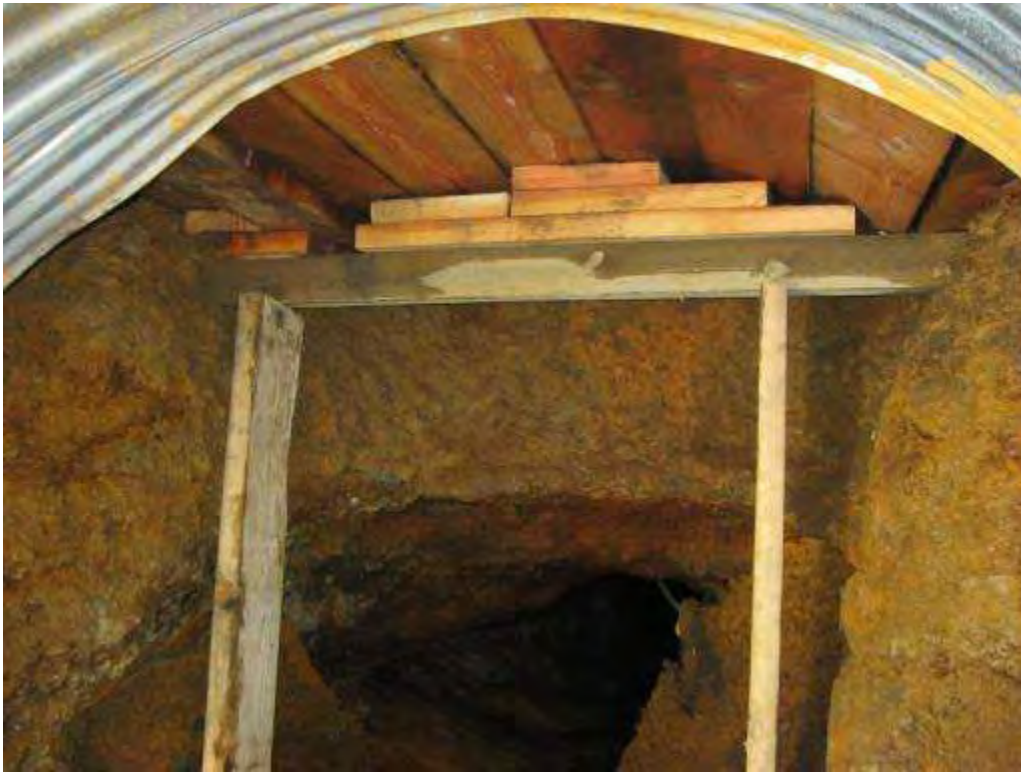
PHOTO 43 10-12-2011
Lagging and bracing between culvert pipe and ferricrete rock at portal.

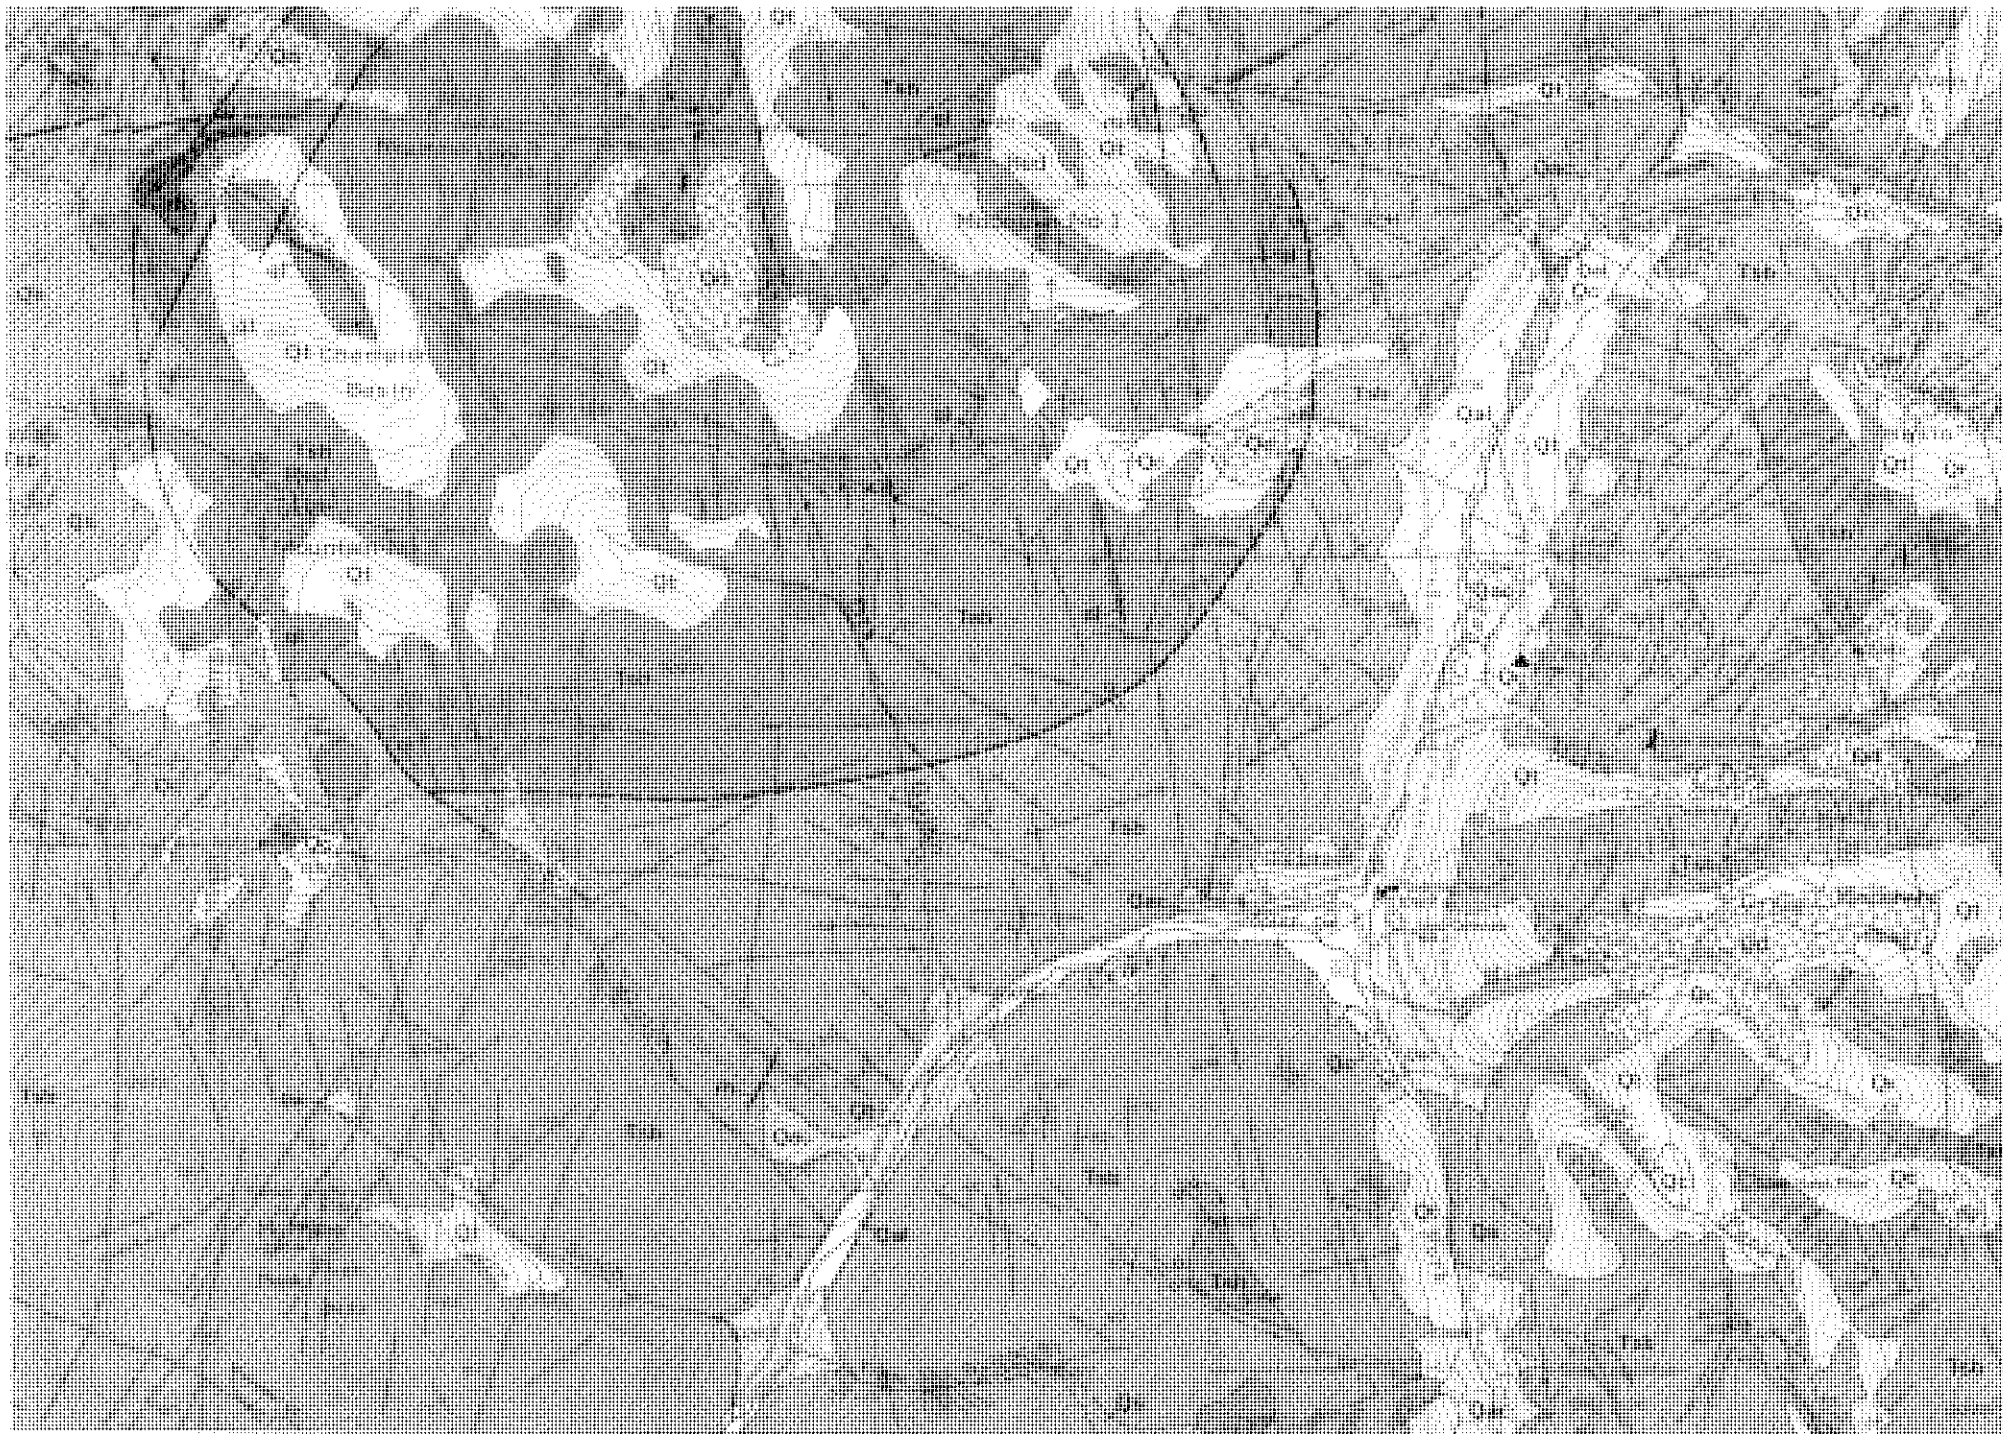
FIGURE 2. SURFACE GEOLOGIC MAP, RED & BONITA MINE AREA.
 ▲ INDICATES MINE LOCATION

Structurally, the Red & Bonita workings lie entirely within the Burns Member described above. The Gold King Vein system lies 2,200 feet east of the portal, and the Bonita Fault lies 3,600 feet east of the portal (Figure 2). At least four other un-named but mapped mineralized fissures striking roughly NE-SW occur in the ground between the portal and the Gold King vein structure (Burbank and Luedke, 1964). There are also five localized, mineralized fissures exposed in the gulch below the Gold King waste dump, however, these do not appear to continue farther north into the R&B ground, and there was no evidence they are the locations of surface groundwater discharge.

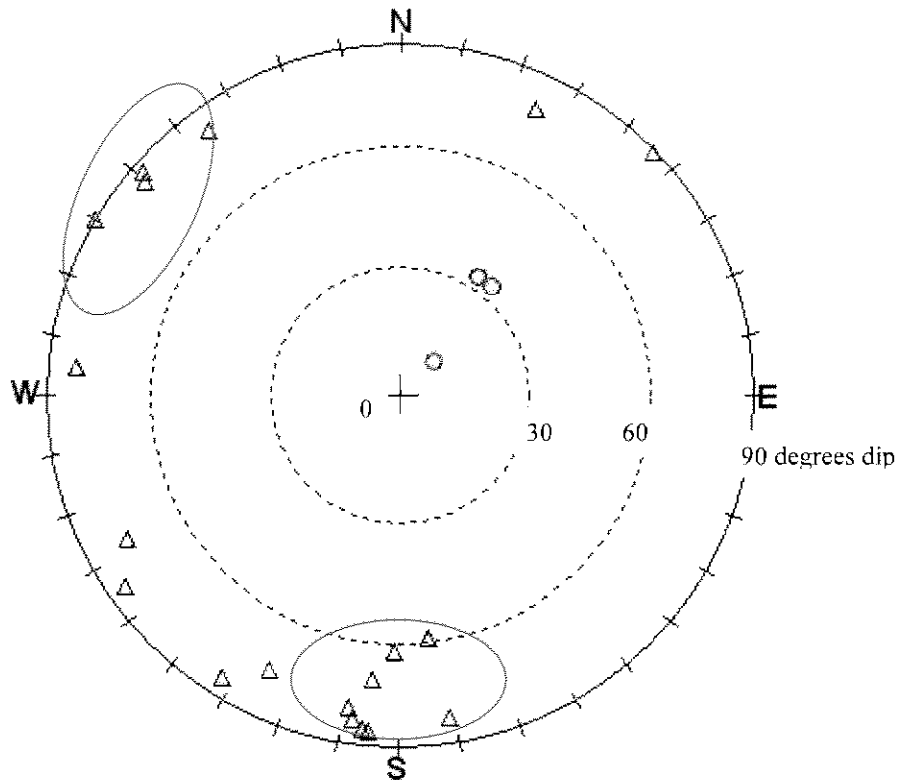
Figure 3. Pole plot of surface planar discontinuities measured around the Red & Bonita Workings. Triangles indicate poles of minor joints; circles indicate poles of flow laminations in andesite rock. The plot shows a cluster of poles to the south and a weaker set in the northwest sector, indicating two trends of anisotropy in the surface bedrock.

The southern pole cluster represents a set of joints trending roughly east-west, with dips of 60 to 89 degrees to the north. The northwest pole cluster represents joints striking roughly northeast-southwest, dipping steeply southeast. These orientations are similar to the dominant northeast-southwest anisotropy noted in the Simon Hydrosearch report prepared for the Sunnyside Mine (Stock, et. al, 1992,1993). They reported permeability greater in a northeast-southwest direction due to the dominant fracture orientation within this section of the Eureka Graben. The structural discontinuities measured in this study tend to agree with the direction of structural anisotropy as shown on published geologic maps and reports for this area near the Eureka Graben. Flow structure (crude bedding) in the andesite strikes south-east and dips gently southwest.

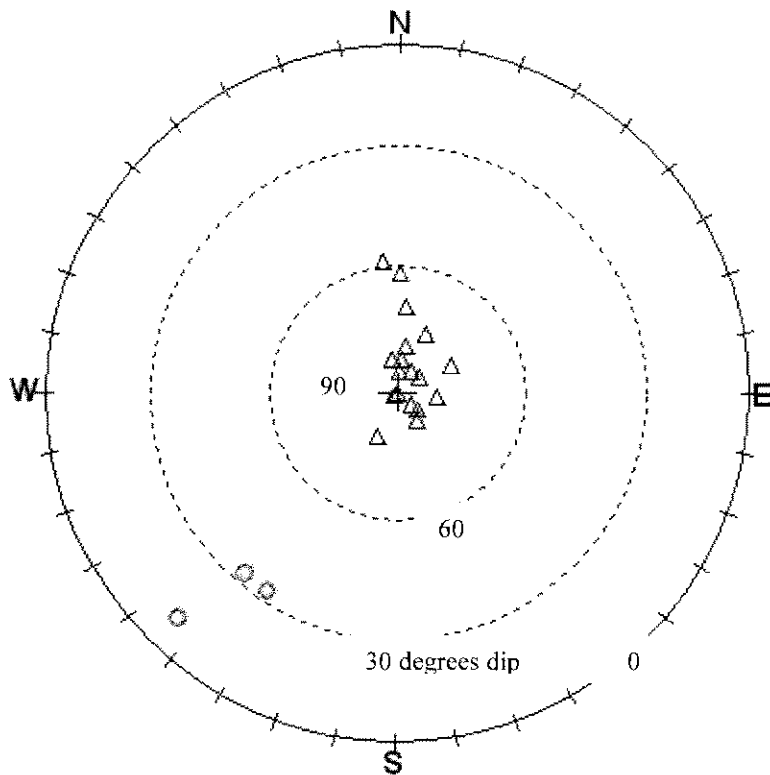
Figure 4. Dip vector plot for planar discontinuities measured on surface around the Red & Bonita workings. Triangles indicate dip of minor joints; circles indicate dips of flow laminations in andesite rock. Most joints are steeply dipping, while flow structure has shallow dips.

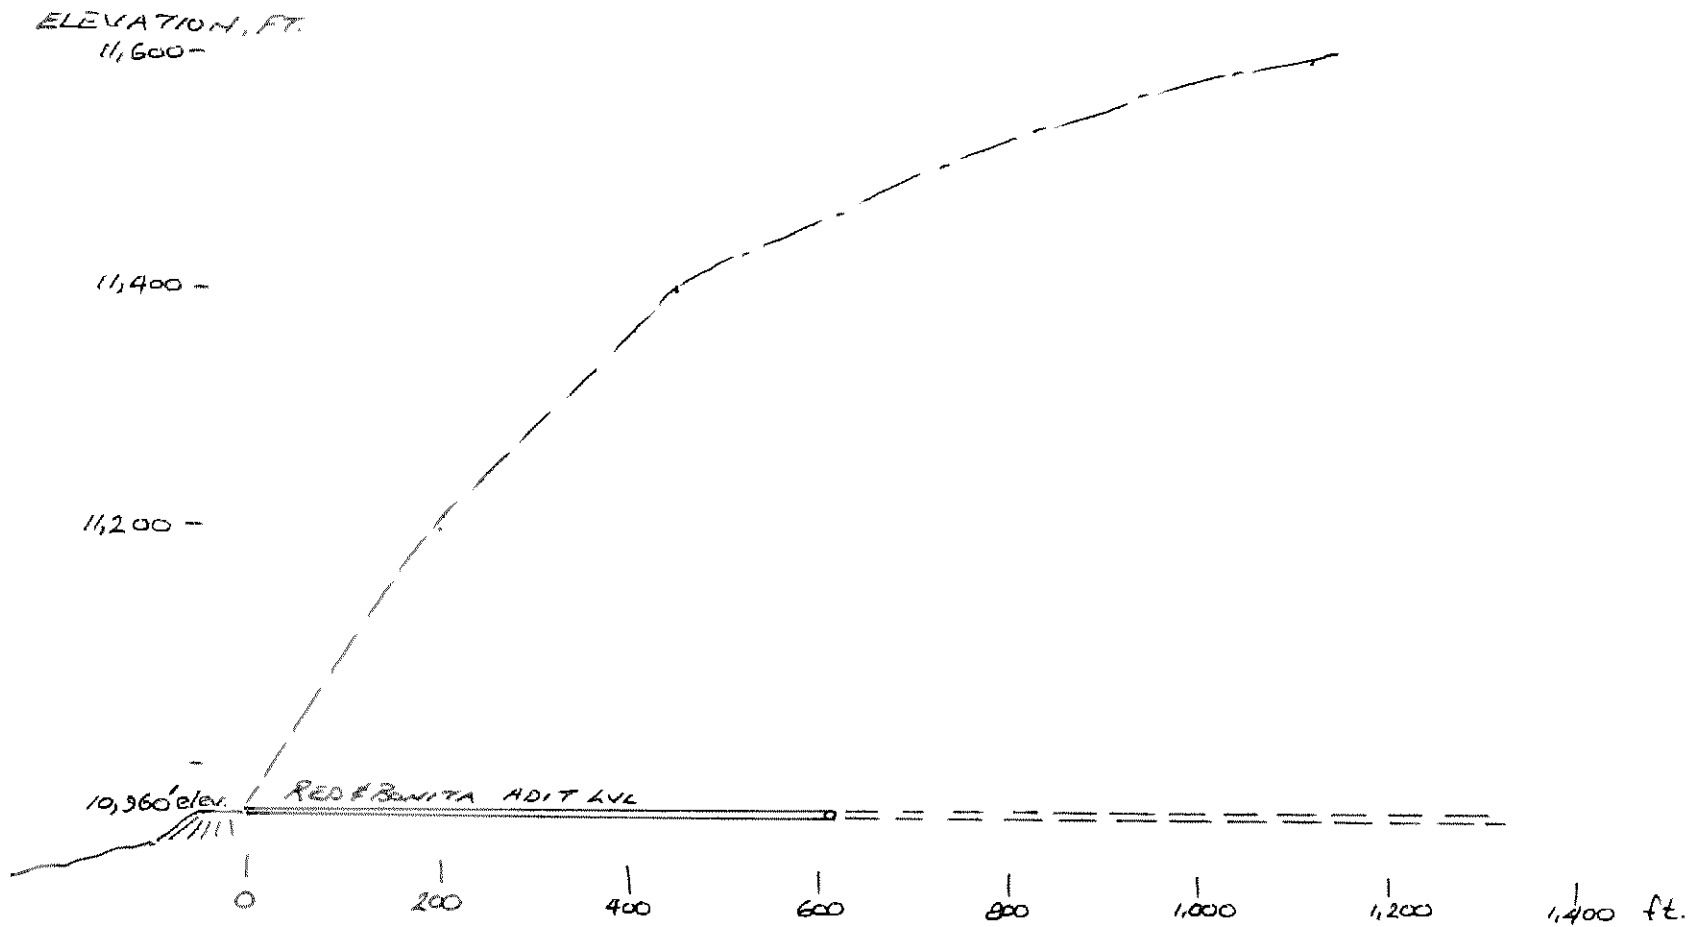
FIGURE 6. DEPTH OF COVER PROFILE ABOVE RED BONITA ADIT

A preliminary cross section along the R&B workings was constructed as part of the bulkhead feasibility consideration (Figure 6). Due to the extremely steep valley walls along Cement Creek there are 400 feet of overburden at 400 feet in from the portal, and 600 feet of depth at 1,000 feet from the portal. A final bulkhead design must take into account the expected pressure head and depth of overburden available to prevent hydro-fracturing of the rock around the bulkhead. In the case of the R&B workings, it appears that sufficient cover exists to continue consideration of a bulkhead if this approach is chosen.

This surface geologic investigation did not indicate any significant structural or undesirable geotechnical conditions that would preclude further consideration of a bulkhead closure approach for discharge control at the Red & Bonita Mine. The bedrock in this area has dominant structural anisotropy (preferred orientation of permeability and flow direction) trending northeast-southwest dipping steeply southeast, and east-west dipping steeply north. The preferred overall groundwater flow direction is thus predicted to be toward the main Cement Creek valley, parallel to the trend of the workings, and generally not toward the adjacent lower section of the gulch below the Gold King Mine. Localized structures and joints do exist that strike in many other directions, making it imperative that a thorough structural analysis of rock exposed in the mine workings be conducted prior to a final bulkhead feasibility analysis. Additionally, if overburden pressure is not sufficient to close minor joints parallel to the trend of the workings at the selected bulkhead location, it could be "short-circuited" by filling of these steeply dipping pathways until they "spill over" and discharge back into the workings on the other side of the plug. A thorough investigation of formation permeability at selected plug locations should be included in any underground evaluation.

The Red & Bonita workings are driven in similar ground and structural conditions to those encountered in the American Tunnel, where bulkheads were successfully installed. The significant depth of the workings below surface at this site should provide sufficient overburden pressures for a bulkhead. The bulkhead would eliminate the present "short-circuit" movement of groundwater through the mine workings and force it back into pre-mining natural pathways. Groundwater is expected to recharge these fracture pathways and eventually find its way to surface in the valley of Cement Creek, reactivating the springs and seeps which existed prior to mining. Flooding of the R&B workings is expected to minimize ARD formation by establishing essentially anoxic conditions in mineralized areas of the mine, significantly reducing formation and transport of dissolved zinc, copper and cadmium from the mined ore bodies to surface waters.

3. The location of any bulkhead should be as far back from the portal and shallow fractured rock aquifer as possible, while avoiding the altered rock zones adjacent to mineralized veins. A thorough investigation of formation permeability at selected plug locations should be included in any underground investigations. This will determine the formation (curtain) grouting needed to seal the rock around the bulkhead. If the bulkhead is placed too close to surface, a great deal more grouting will be required to isolate the impounded water from communicating with the near-surface fractured rock aquifer, and there is a higher degree of risk that water will find a pathway around the bulkhead.

4. If a high-head condition is predicted for a bulkhead, it might be more cost effective to consider the "multiple leaky plugs" approach to save drilling and curtain grouting costs.
